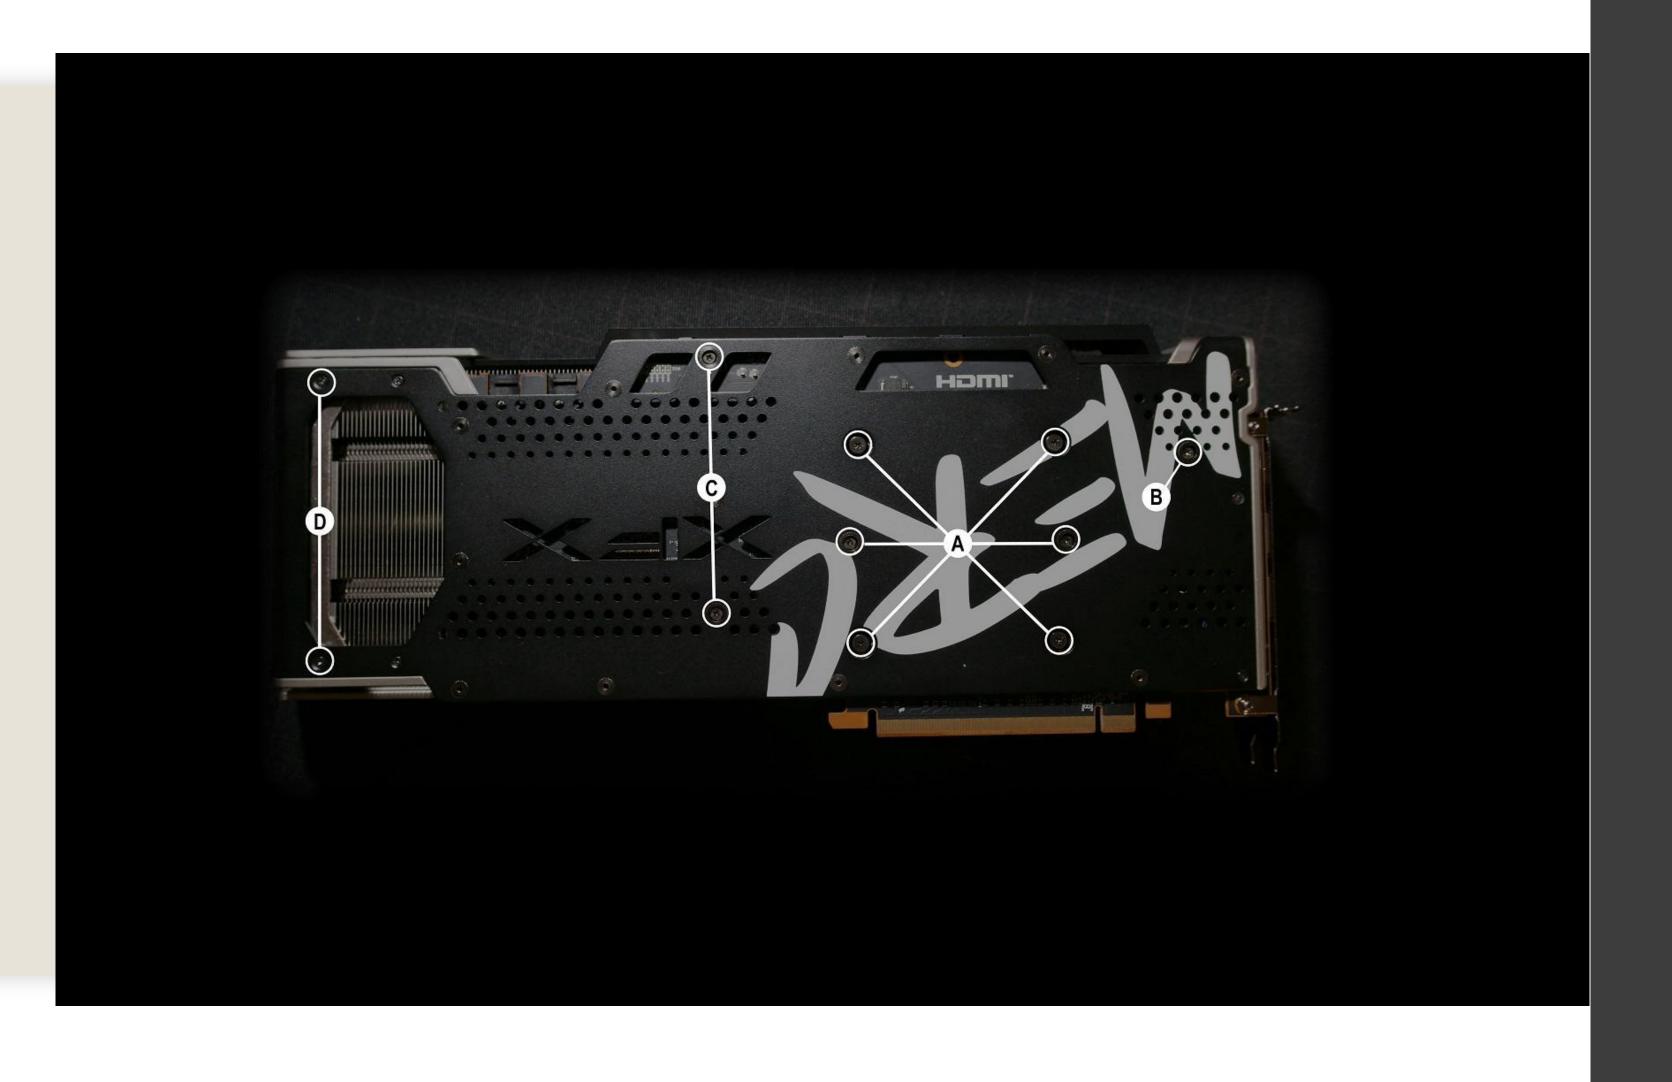
Once removed the entire fan shroud and heatsink assembly will separate from the graphics card. Take care not to pull the assembly too far from the PCB as the fan wire will still be attached.

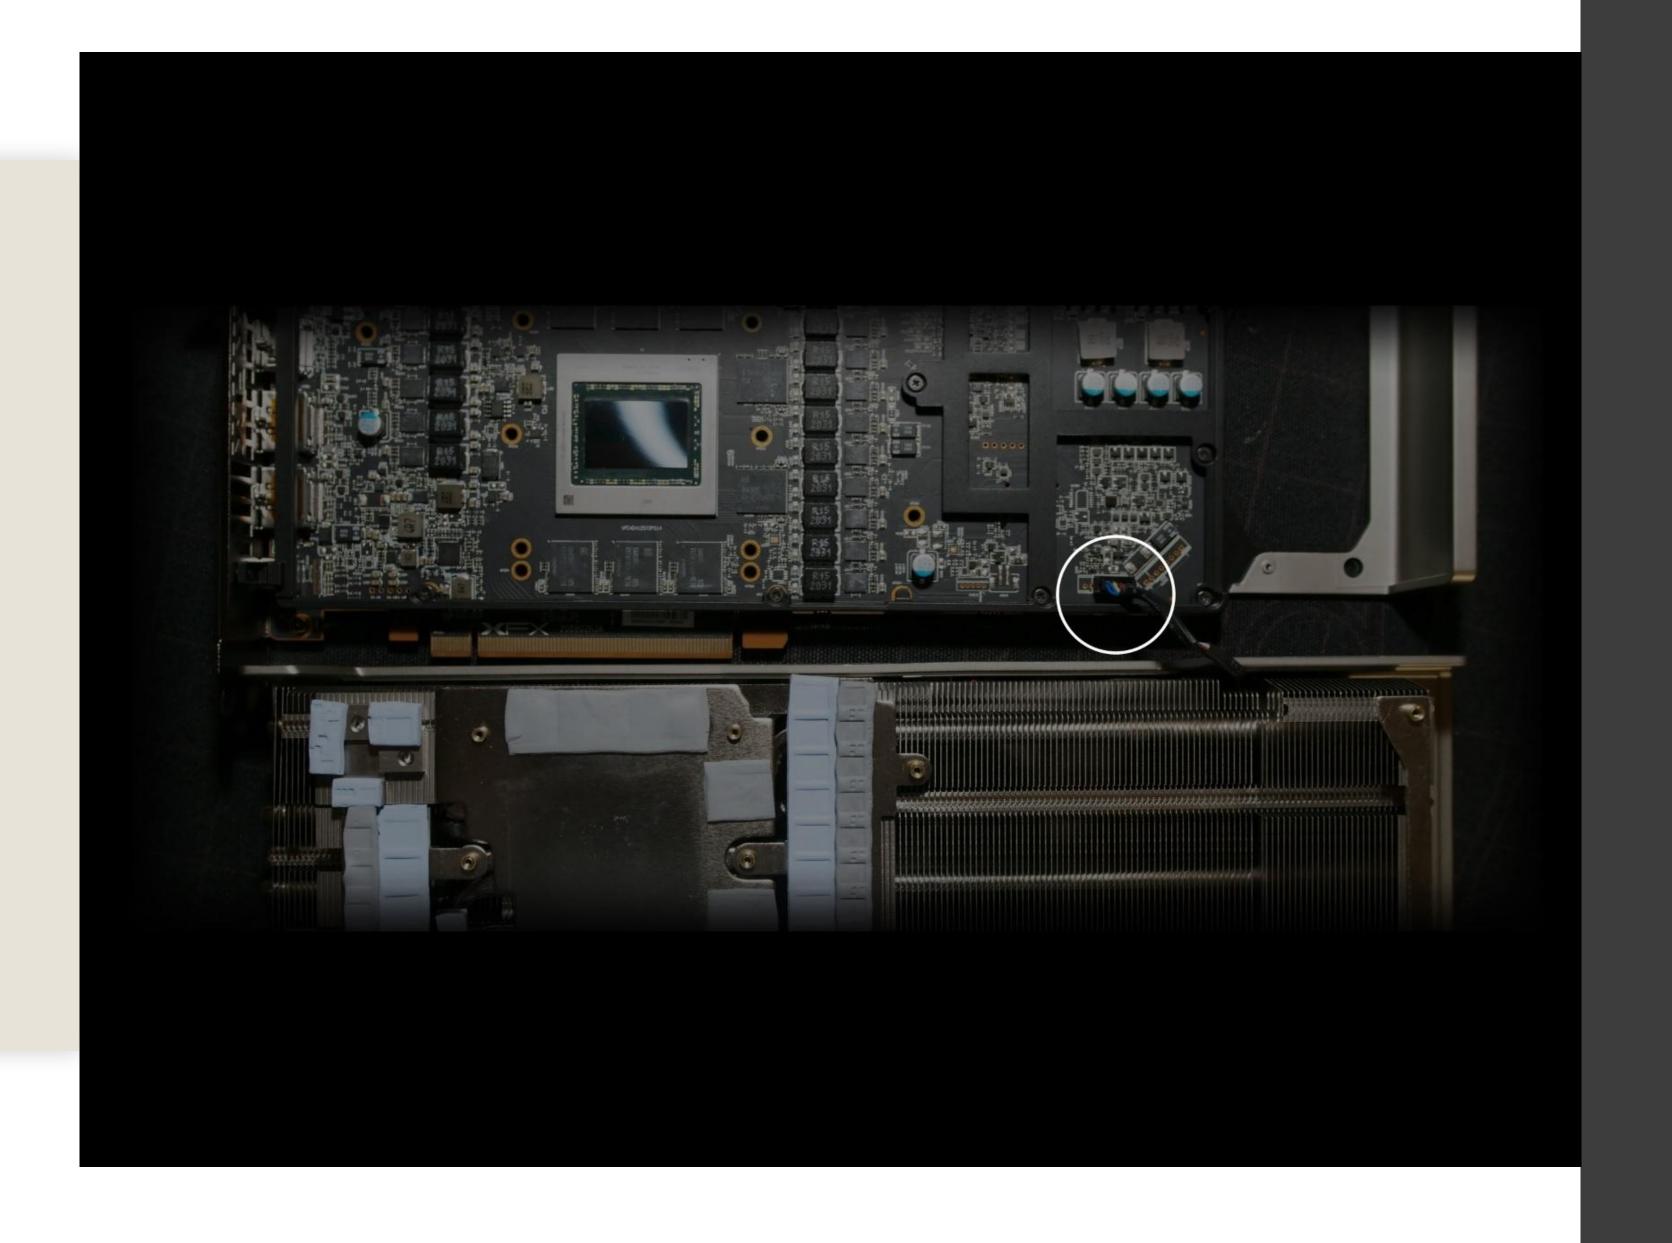
The fan wire is attached to the show below, take great care when removing the fan wire connection, the header can be delicate, tweezers or another precision instrument are recommended to release the lock mechanism on the header.

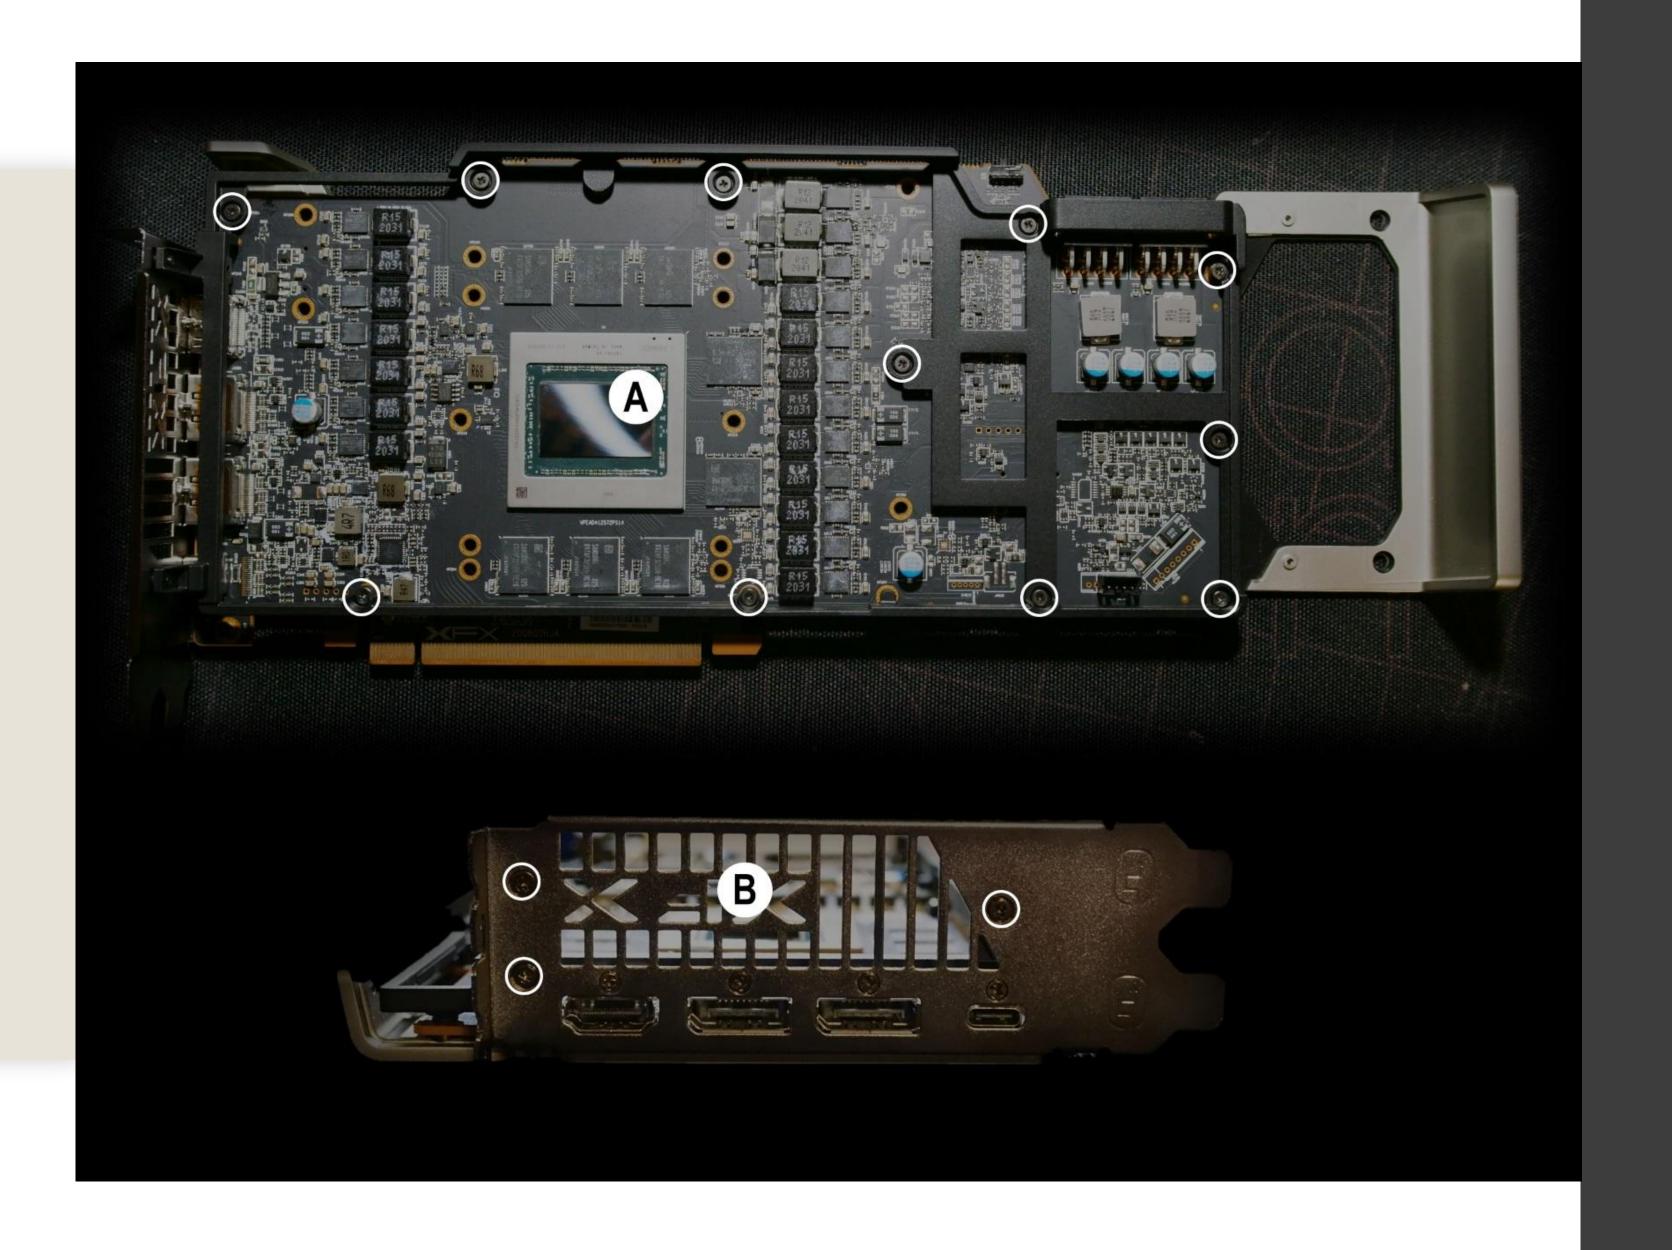
Once the fansink assembly is removed, the support tray is visible. The support tray is tied directly into the backplate, all visible tray screws will need to be removed to take off the tray and backplate.

- A. 11 Screws through PCB
- B. 3 Screws on I/O Plate

After all 14 screws above are removed, both the support tray and the backplate will separate from the PCB. Take care not to damage thermal pads when removing these components.

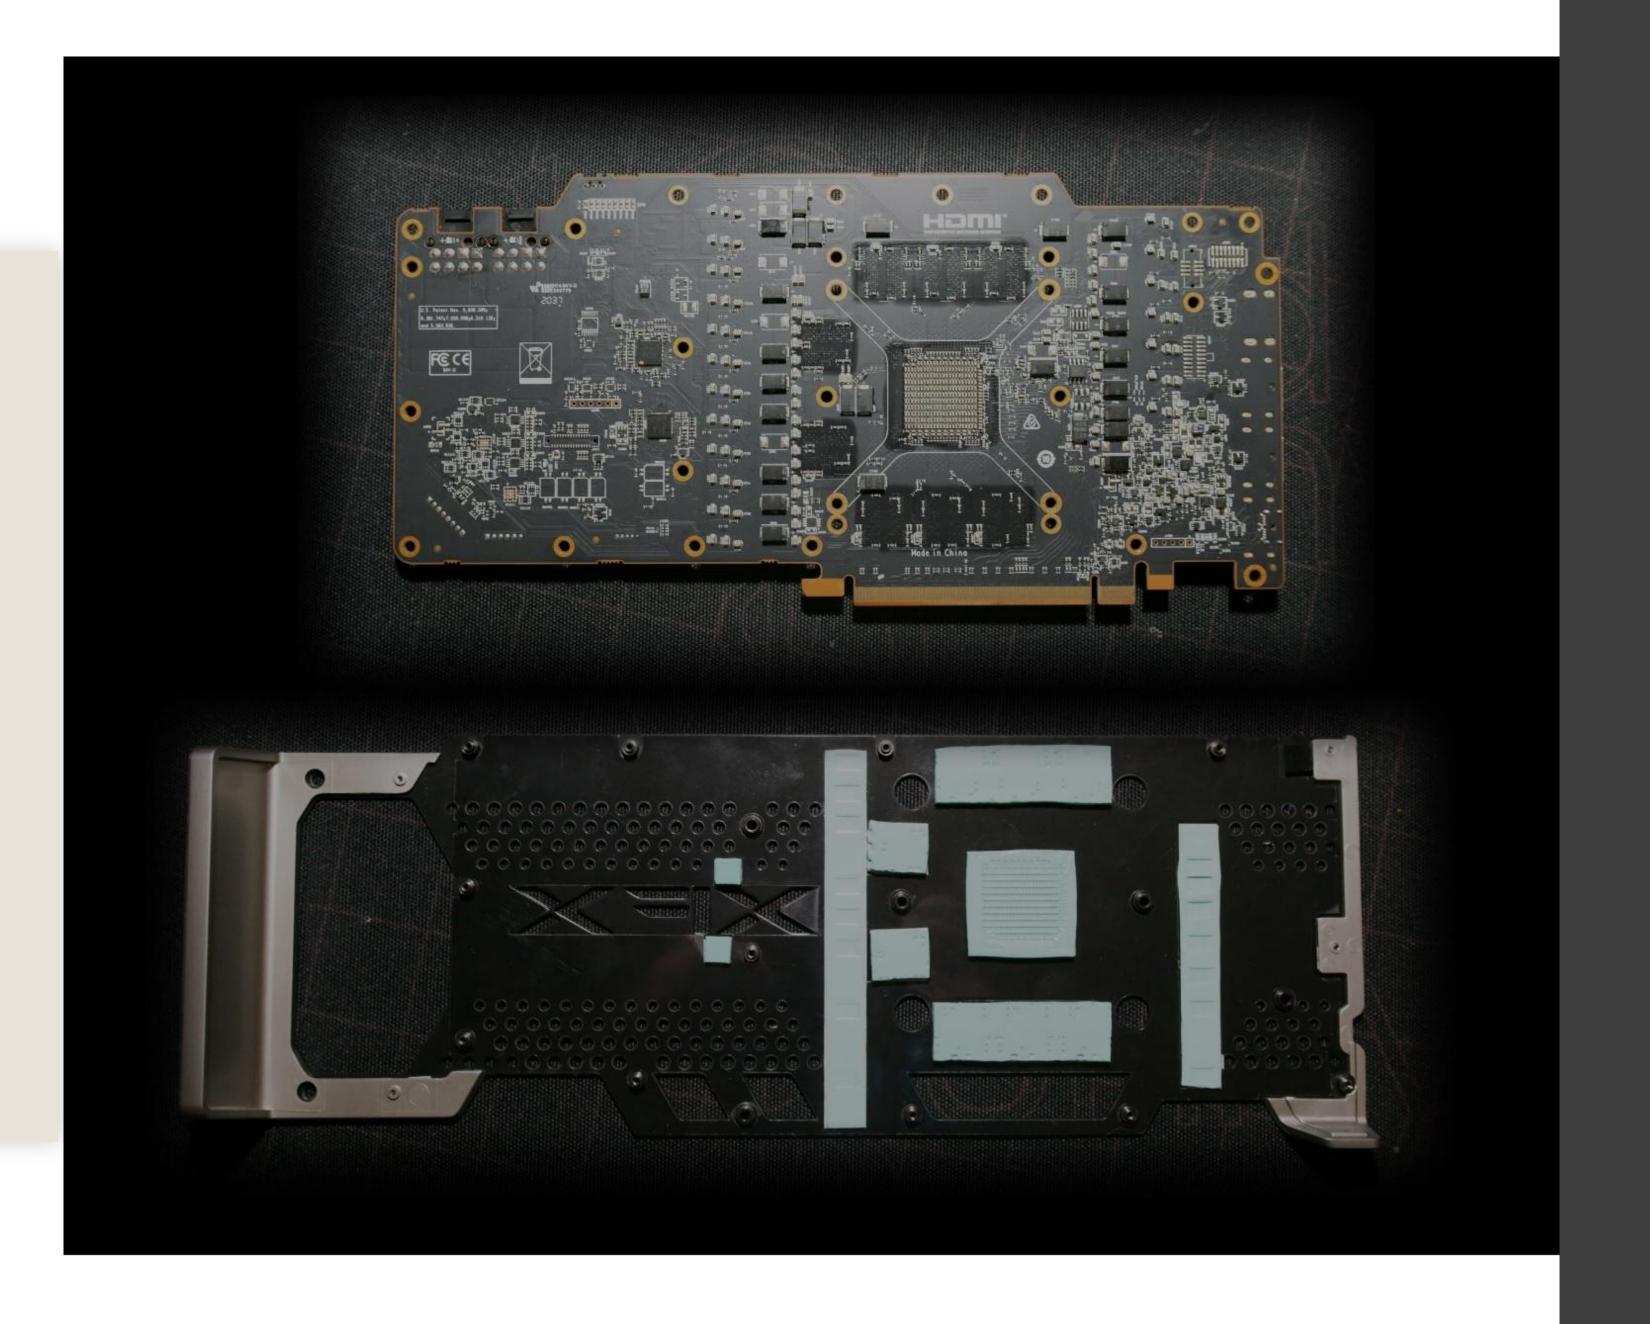
Back plate and back thermal pads.

On reassembly, it is important that the 4 screws holding the primary heatsink to the GPU are torqued / tightened as evenly as possible. The Navi GPU can be sensitive to uneven mounting pressure to the coldplate. Uneven mounting pressure will lead to Junction temperatures spikes and unpredictable fan behavior.
